UNIVERSITY OF TEXAS AT AUSTIN
ME 384N – ARCHITECTURAL ACOUSTICS

Survey of Audio Recording Environments

Dan Hemme

20 May 2013

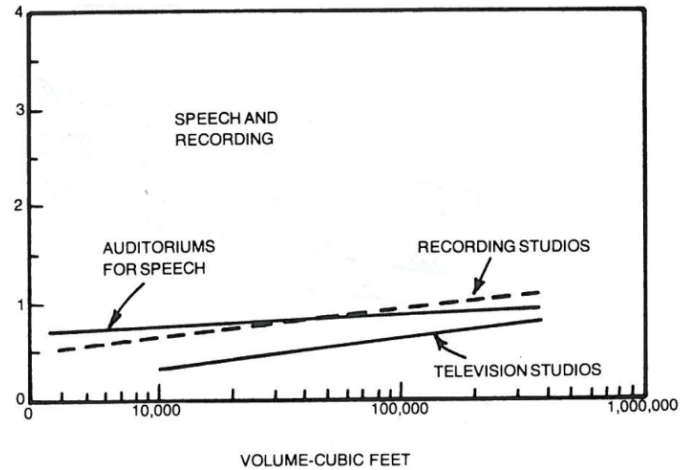
Figure 1.2- Recommended reverberation decay times for studios

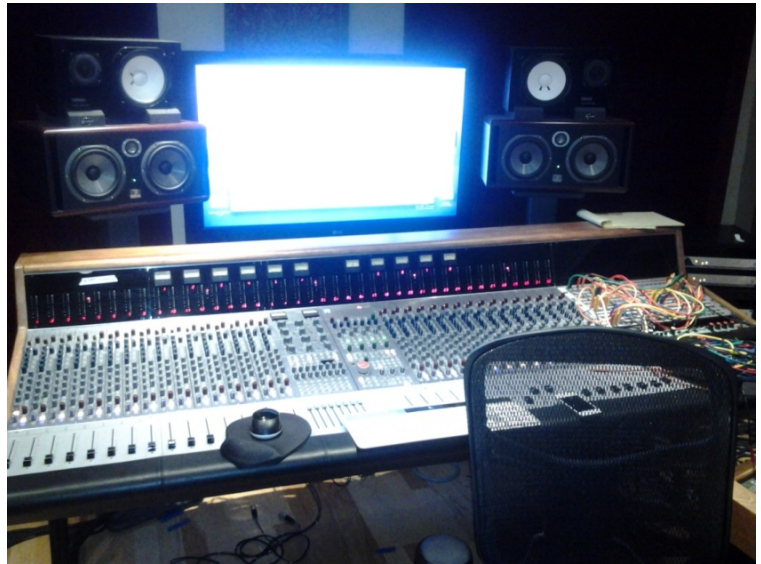
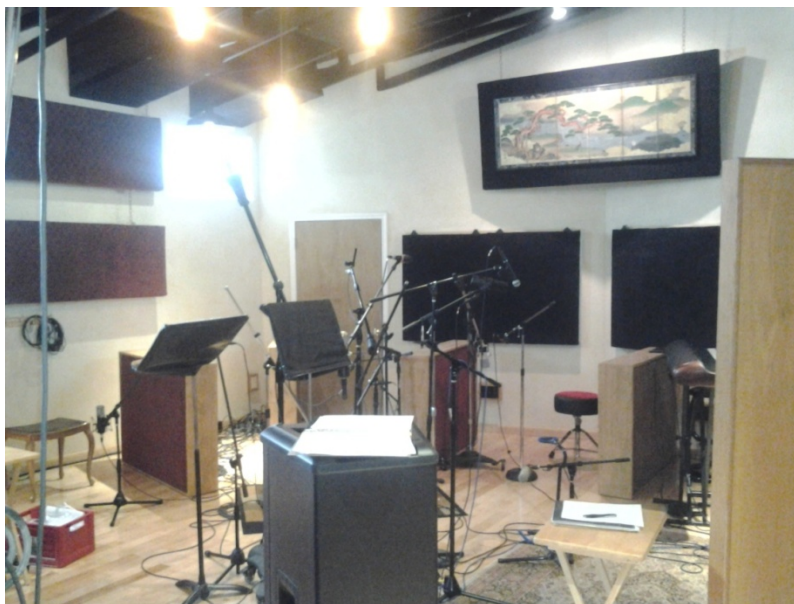
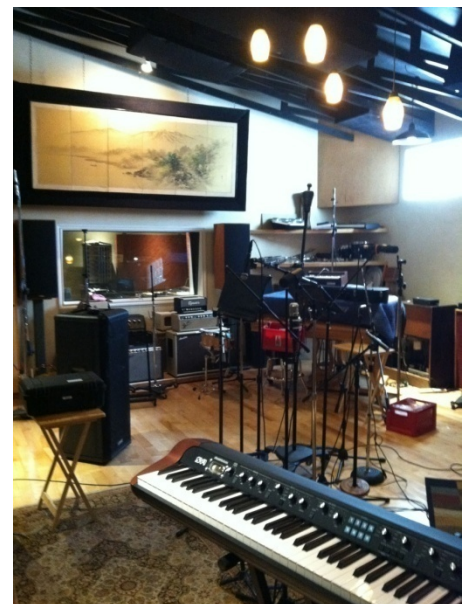
Figure 2.1- Austin Signal Control Room (top) and Tracking Room (bottom left and right)

The Tracking Room is a moderately large room (approximately 476ft², 6,200ft³); the Control Room is considerably smaller than, and located adjacent to, the Tracking Room. Interior views of both rooms are shown in Figure 2.1. Floor plan and section views of the studio are shown in Figure 2.2. Note that these drawings do not reflect some changes made during construction, namely the size of the Isolation Booth shown at the top-right corner was increased by reversing the slope of the wall, as shown sketched in.

A portion of absorptive panels at the ceiling are installed with foil facing exposed under the fabric wrapping, and a portion of the panels installed at the walls are covered with artwork; these conditions may result in reduced absorption, especially at higher frequencies.

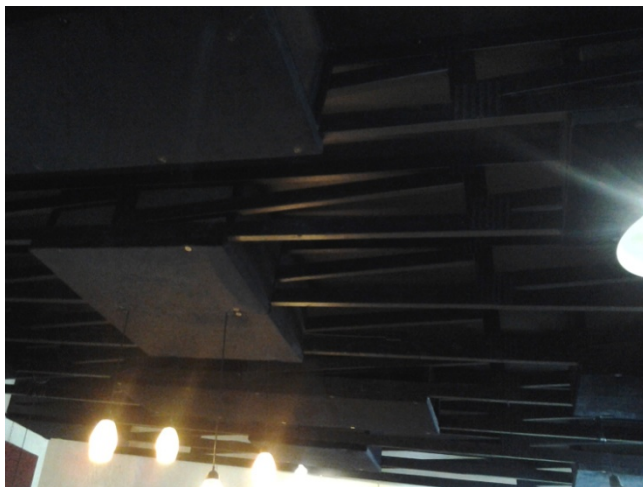
Figure 2.3- Acoustical absorption installed at the ceiling

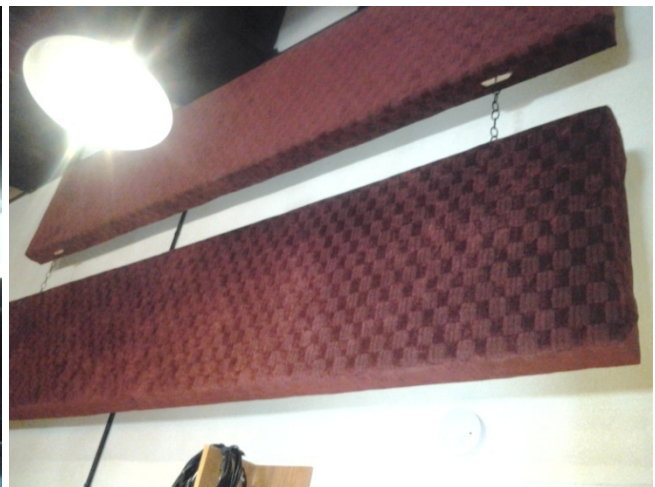
Figure 2.4- Acoustical absorption at the wall is hung from the ceiling with an airspace behind

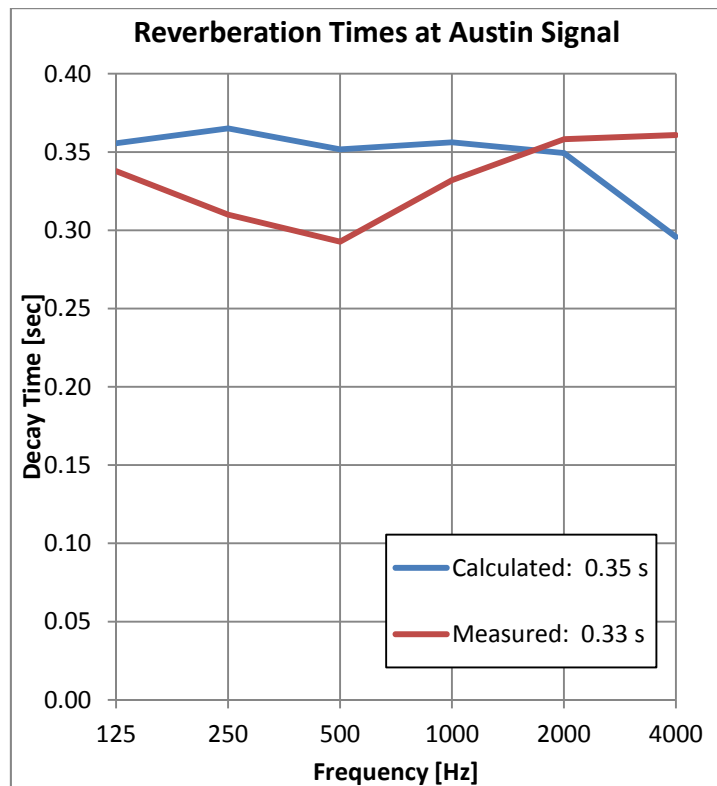
The reverberant spectrum is fairly even throughout the audible frequency range; it was measured at 0.33 seconds, and calculated at 0.35 seconds, broadband, see Figure 2.5. At the time of our visit, there were 5 gobos set up throughout the Tracking Room. The discrepancy between measured and calculated values can most likely be attributed to discrepancies between materials and mounting types used in laboratory tests versus the installed condition.

Figure 2.5- Reverberation time in the Tracking Room

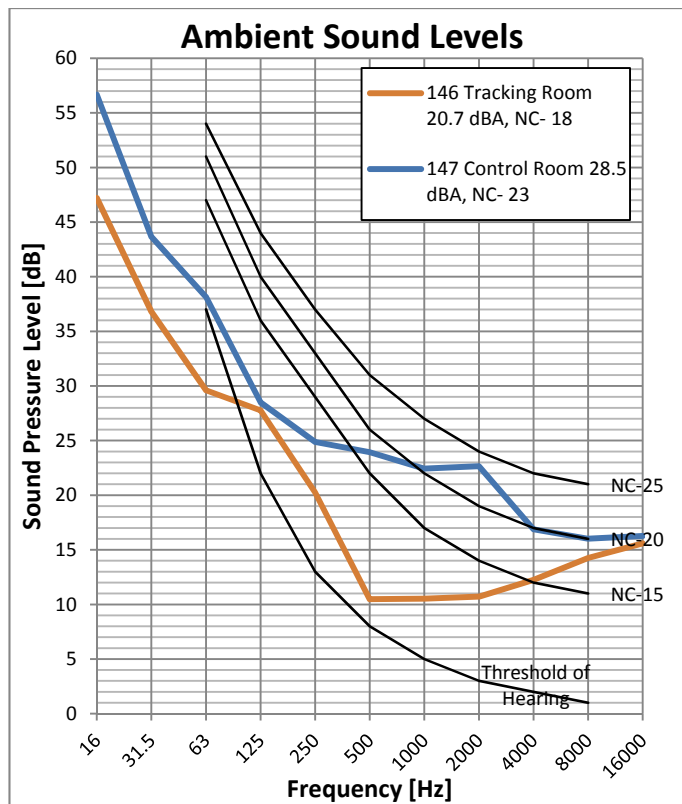
Ambient sound levels in the Tracking and Control Rooms were measured, with the HVAC system in operation, at 20.7dBA, NC-18 and 28.5dBA, NC-23 respectively (see Figure 2.9). In other words, conditions

Figure 2.9- Ambient sound levels in the Tracking Room and the Control Room

are within recommended guidelines. The peak in the 2kHz octave-band seen in the Control Room is likely due to equipment noise.

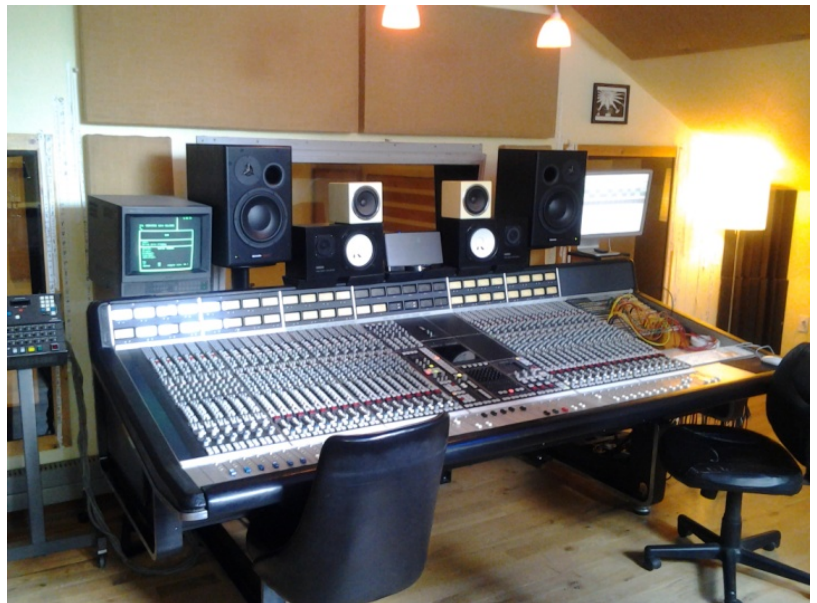
Figure 3.1- Interior view of Control Room

The Tracking Room is a fairly large room (approximately 675ft², 8,500ft³) on the ground level. The Control Room is considerably smaller, and is located on the second level, with three large windows overlooking the Tracking Room. Interestingly, there is not a door at the Control Room; the stairway from the ground level entryway leads directly to the Control Room. The Isolation Booth is located off of the Tracking Room. The Machine Room is tucked behind the Isolation Booth, and houses a large equipment rack with the console power supply, power amplifiers, etc.; this room is served by a dedicated HVAC unit. The Control Room is shown in Figure 3.1, and several views of the Tracking Room and Isolation Booth are shown in Figure 3.2.

The decision to position the Control Room overlooking the Tracking Room was made late in the design, as a measure to increase the size of the Tracking Room. Issues that have been encountered due to the location of the Control Room include difficulties moving large pieces of equipment into and out of the Control Room, and the possible need for additional structural bracing below the console.

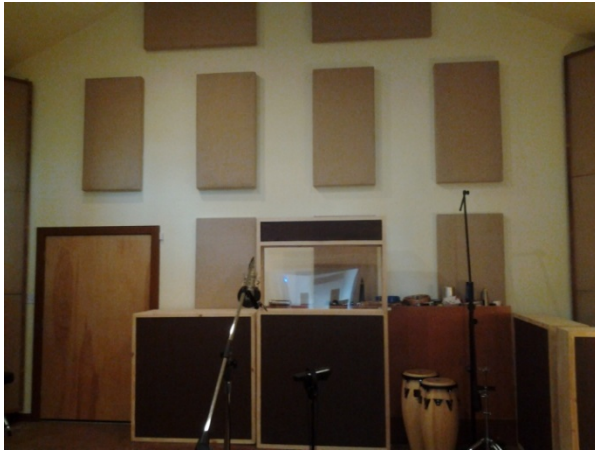
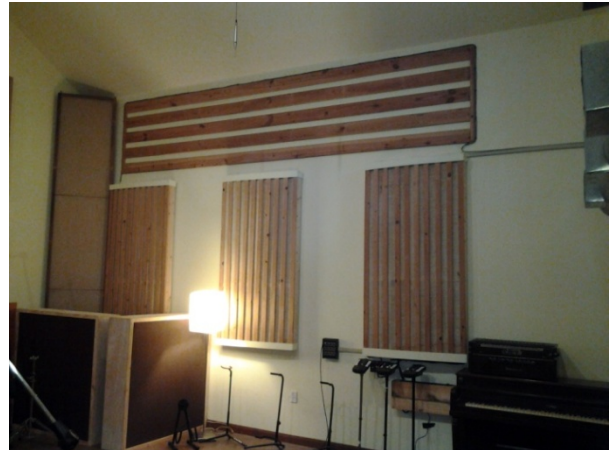
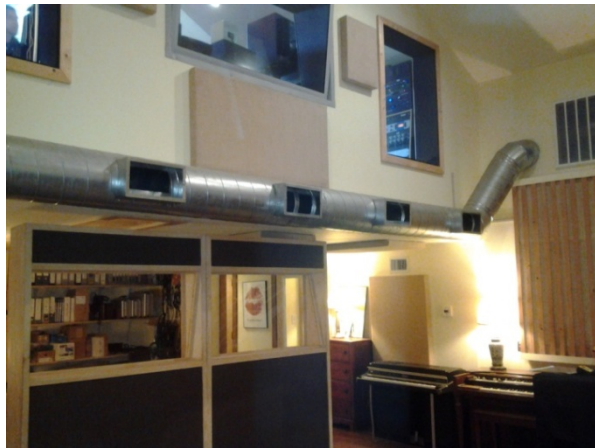
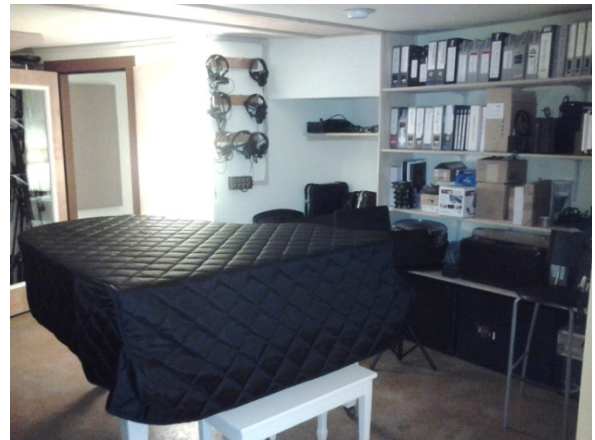
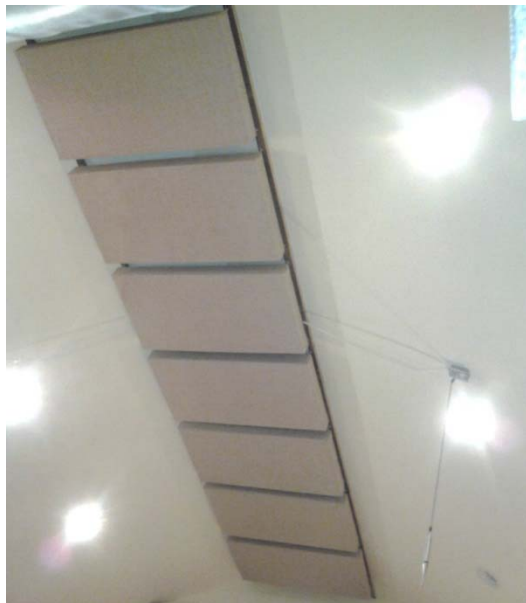
Figure 3.2- Interior views of EAR – Note the exterior door, plate reverb, and wall panels, top-left; bass trap and wall panels, top-right; wall between Tracking Room and Control Room, center-left; low ceiling area of Tracking Room, center-right; acoustical treatment at Tracking Room ceiling, bottom-left; Isolation Booth with door to Machine Room visible, bottom-right

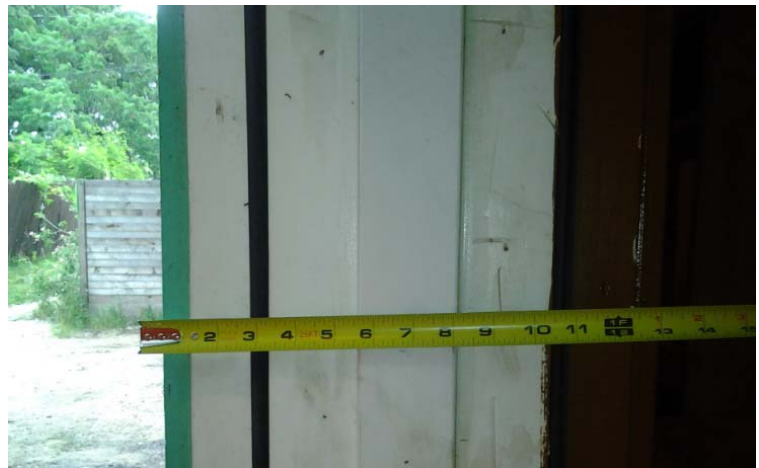
The Tracking Room is isolated from the exterior by a sound isolation wall assembly that is more than 12" thick (see Figure 3.4), constructed of double wood stud walls separated by an air gap, with fiberglass batt insulation in the stud cavities, and faced with multiple layers of gyboard. The exterior doorway is fit with two solid-core wood doors – one on the exterior and one on the interior set of studs. There are no exterior windows in the Tracking Room.

Figure 3.4- Exterior wall is more than 12" thick.

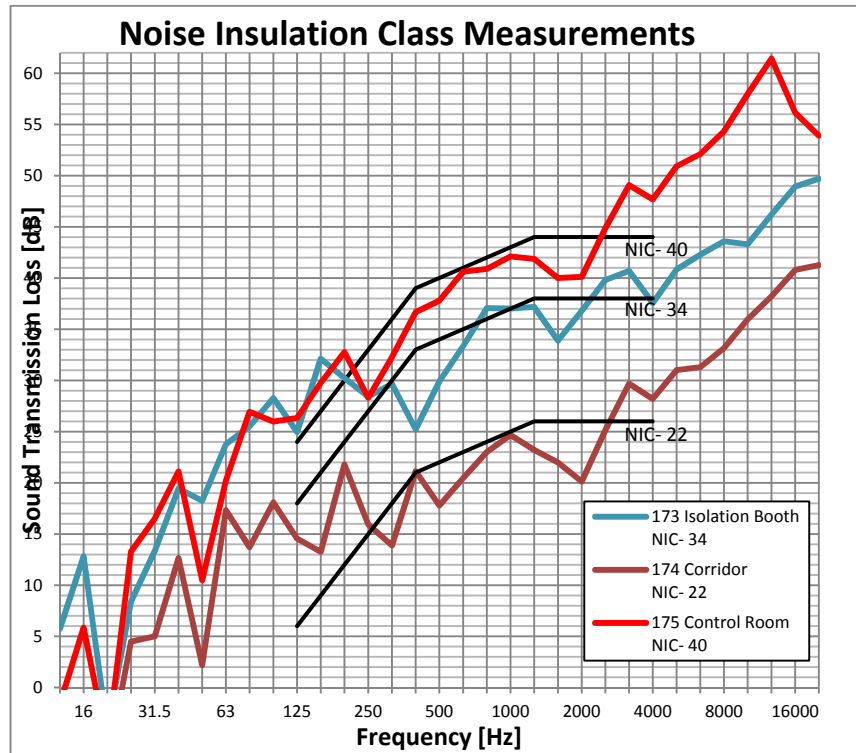
Figure 3.5 shows the results of sound isolation measurements obtained by placing the noise source in the Tracking Room, and measuring sound pressure levels in the Isolation Booth, Corridor, and Control Room. Isolation between these areas was measured at NIC-34, NIC-22, and NIC-40, respectively. Note that in the case of the Control Room, this value represents sound isolation provided by the wall and floor/ ceiling structure. By most measures these isolation values would be considered very low for this type of facility. However, sound isolation between

Figure 3.5- Results of sound isolation testing between the Tracking Room and the Isolation Booth, Corridor, and Control Room

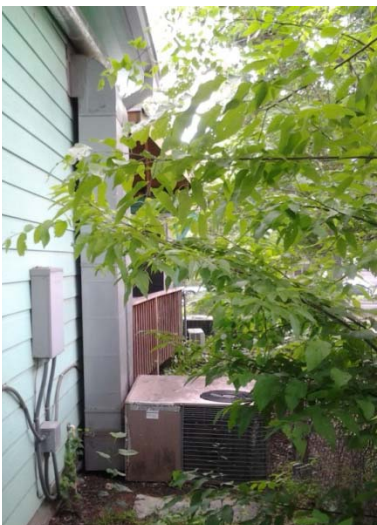
The HVAC needs of the studio are served by two fan units – one each for the Control and Tracking Rooms. Both units are located outdoors, shown in Figure 3.7, with rectangular sheet metal ductwork running up an exterior wall before entering the building. It is not clear how much of the ductwork includes internal lining; supply ductwork in the Tracking Room was found not to include internal lining (see Figure 3.8), while return ductwork in the Control Room was found to be internally lined. Most of the supply air registers throughout the studio have been removed, as shown in Figure 3.9, and the replaceable filters used at return air grilles are

Figure 3.7- Exterior HVAC fan units with exposed ductwork.

Background noise levels in sound-critical areas conform to recommendations when the HVAC system is not in operation; when the system is activated sound levels increase significantly, particularly in lower octave-bands. This can be addressed by installing duct silencers in exterior portions of ductwork.

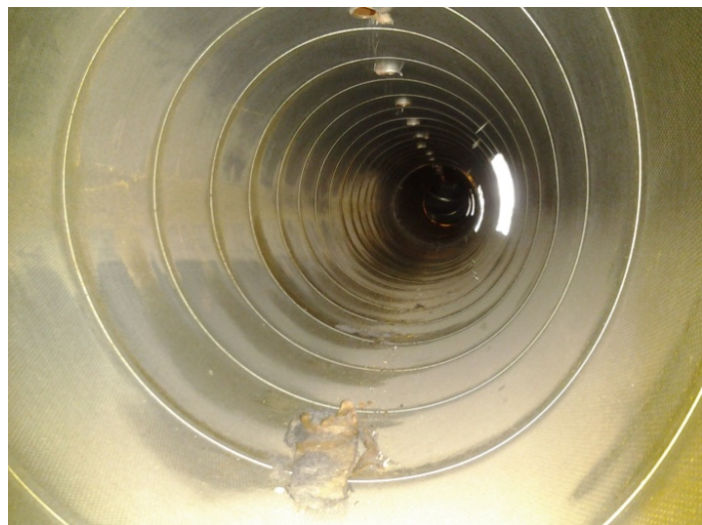
Figure 3.8- Inside of Tracking Room ductwork, note lack of internal lining.

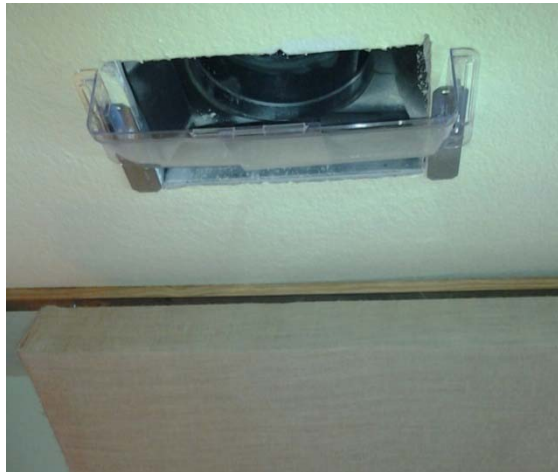
Figure 3.9- HVAC diffusers were removed throughout the studio.

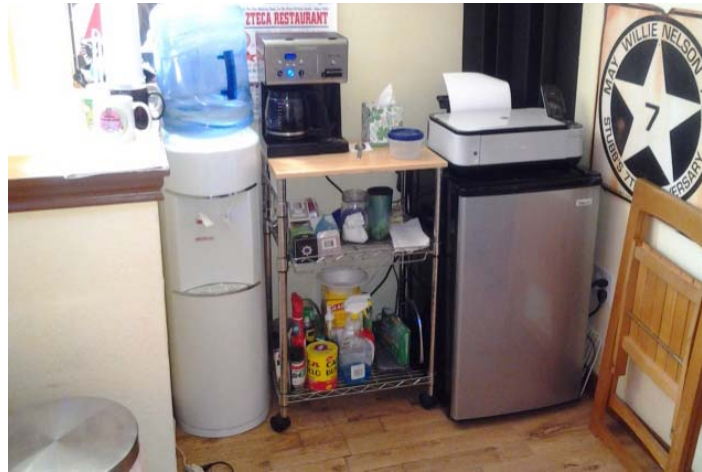
Figure 3.10- Several noise producing appliances located in the Control Room

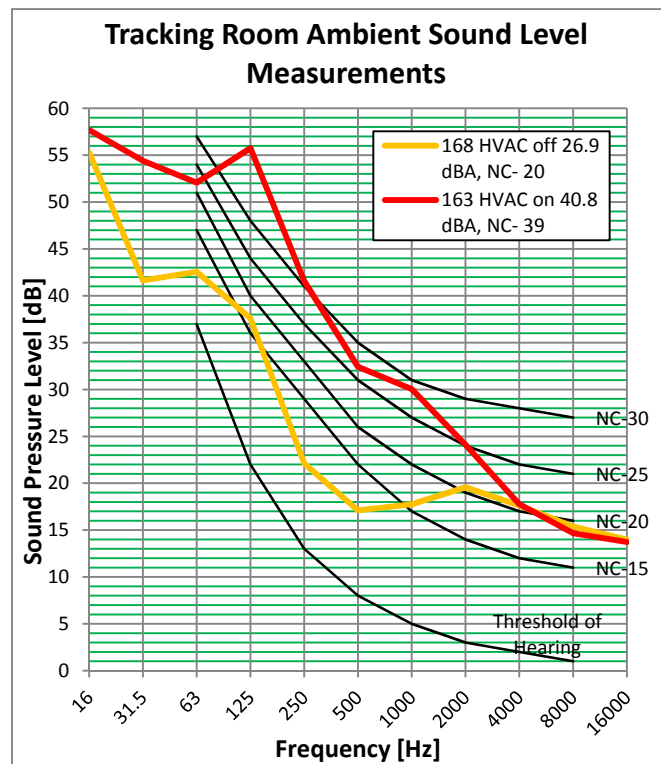
Ambient sound levels in the Tracking Room were measured at 26.9dBA, NC-20 with the HVAC system off, and 40.8dBA, NC-39 with the HVAC system on (see Figure 3.11). In other words, conditions were within recommended guidelines with the HVAC system off, but were well above recommended levels, due to significant increases in the lower octave-bands, with the system on. The situation is

Figure 3.11-Ambient sound levels in the Tracking Room with the HVAC system on and off

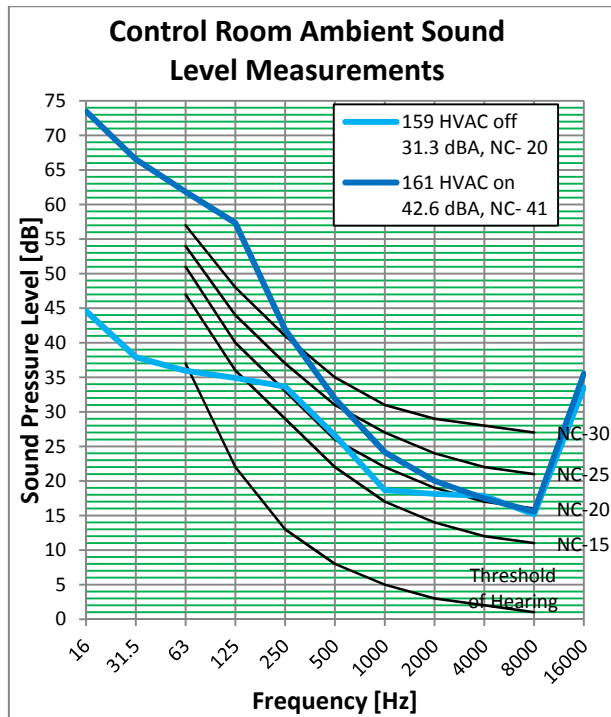
Figure 3.12-Ambient sound levels in the Control Room with the HVAC system on and off

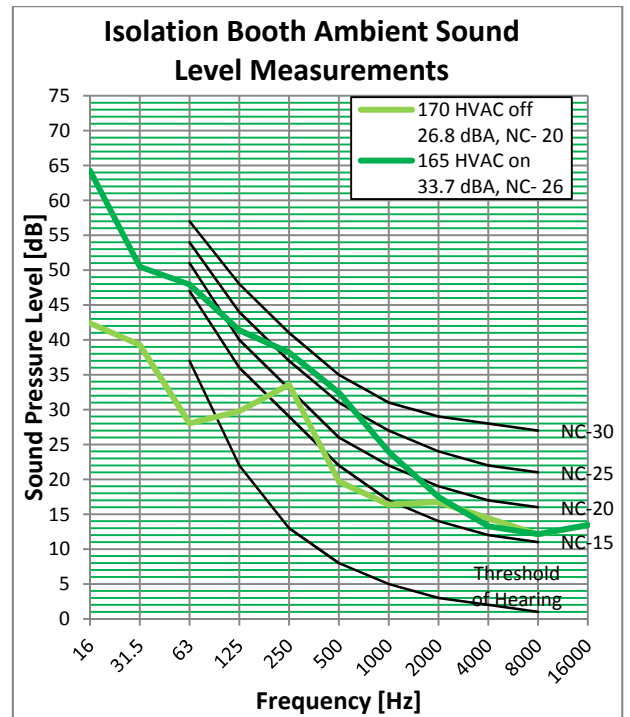
Figure 3.13-Ambient sound levels in the Isolation Booth with the HVAC system on and off

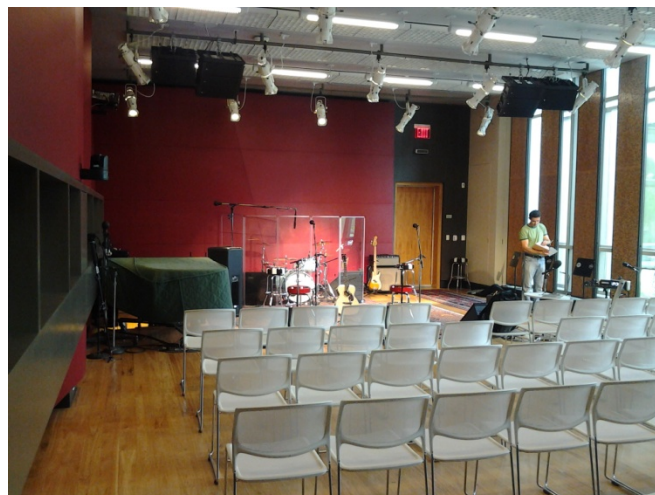
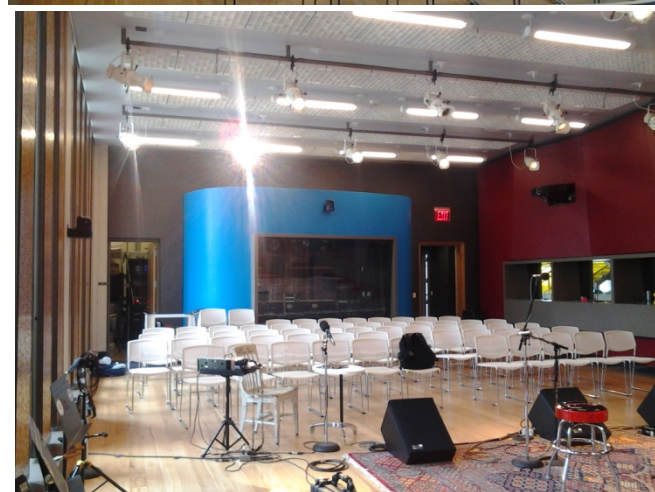
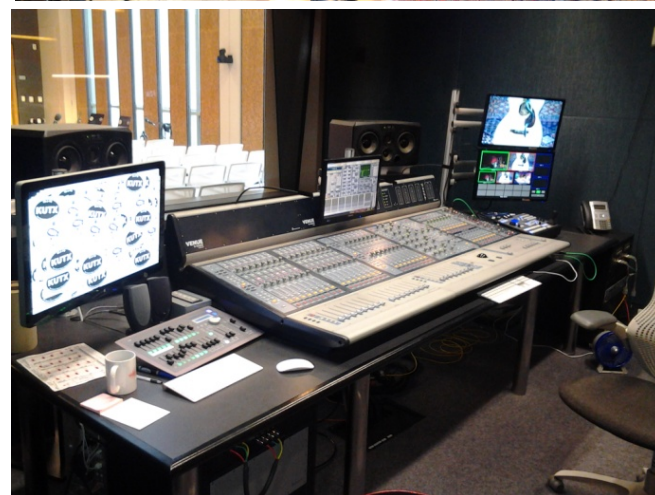
Figure 4.1-Interior of the Tracking Room from the northeast (top) and southwest (middle) corners, and the Control Room (bottom)

The Tracking Room is a relatively large room (approximately 1,230ft², 17,920ft³), which can accommodate a live audience of approximately 60 people (see Figure 4.1). The Control Room is considerably smaller than, and located directly to the south of, the Tracking Room. Floor plan and section views of the Studio area are shown in Figure 4.2.

The Tracking Room floor is made of locally sourced pecan wood, and is accented with several large area rugs around the performance area. The finish ceiling installed at 14'-4" above the finish floor, and is made primarily of gypboard with approximately 30% of the surface area covered by acoustical diffusers, shown in Figure 4.3, which serve to discourage flutter echo between the otherwise parallel and acoustically reflective surfaces of the floor and ceiling. The diffusers also provide a feeling of spaciousness in the room which is not typically found in a recording environment, but which provides for a more natural listening environment for the live studio audience.

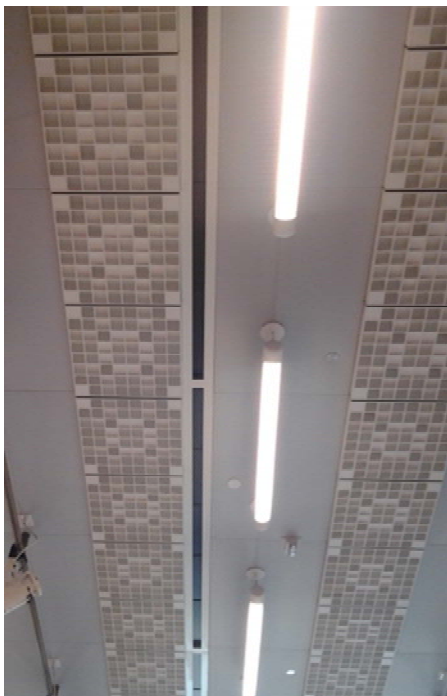
Figure 4.3- Ceiling mounted acoustical diffusers

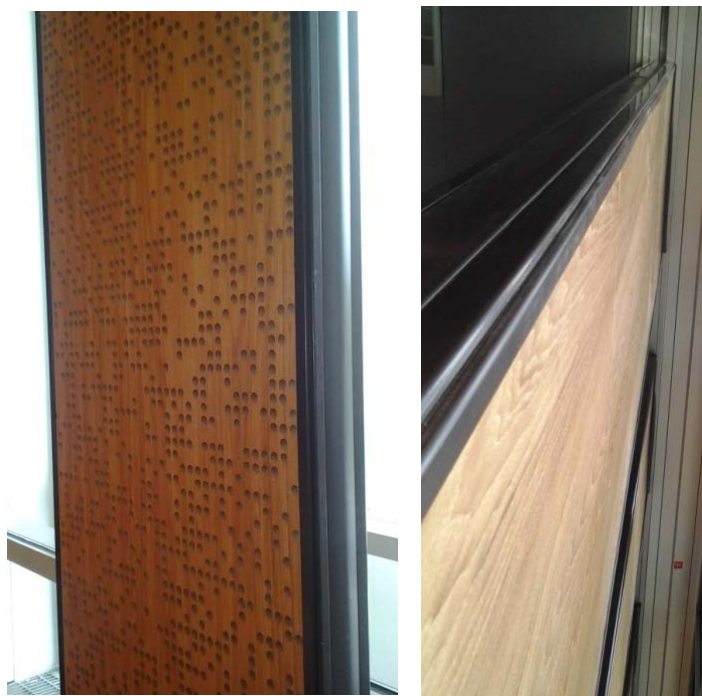
Figure 4.4 Variable acoustic panels in the Tracking Room – absorptive side (left); reflective side (right)

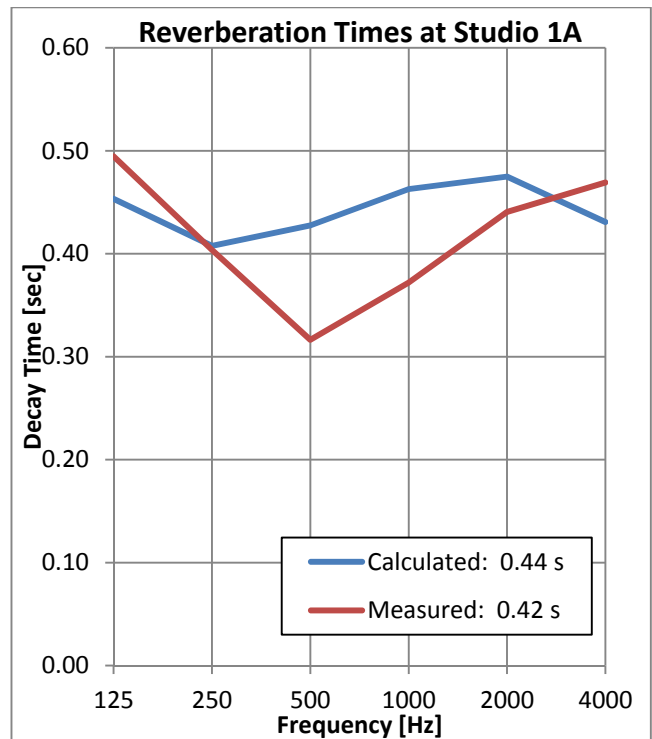
Reverberation decay time was measured at 0.42 seconds, and calculated at 0.44 seconds, broadband. Figure 4.5 shows the decay times across the audio frequency range. Discrepancies between measured and calculated values are probably due to the variable thickness of the absorptive treatment; absorption values for 4" thick fiberglass were used for calculations, as this is the thickest treatment for which data was available.

Figure 4.5- Reverberation time in the Tracking Room

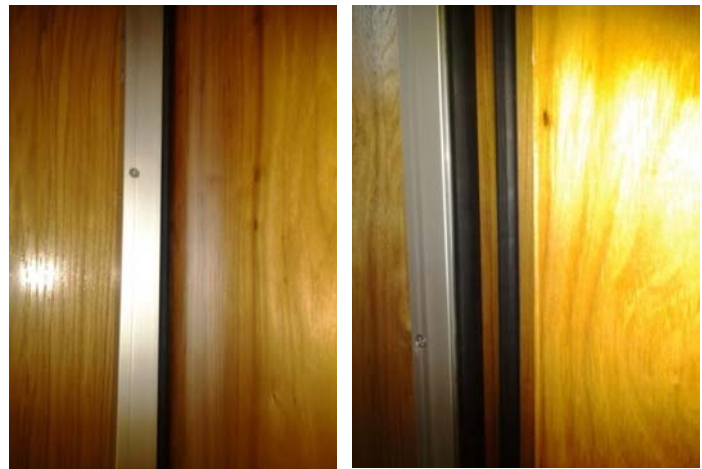
Figure 4.7- Adjustable door seals at Vestibule/ Tracking Room door – door closed (left) and door open (right)

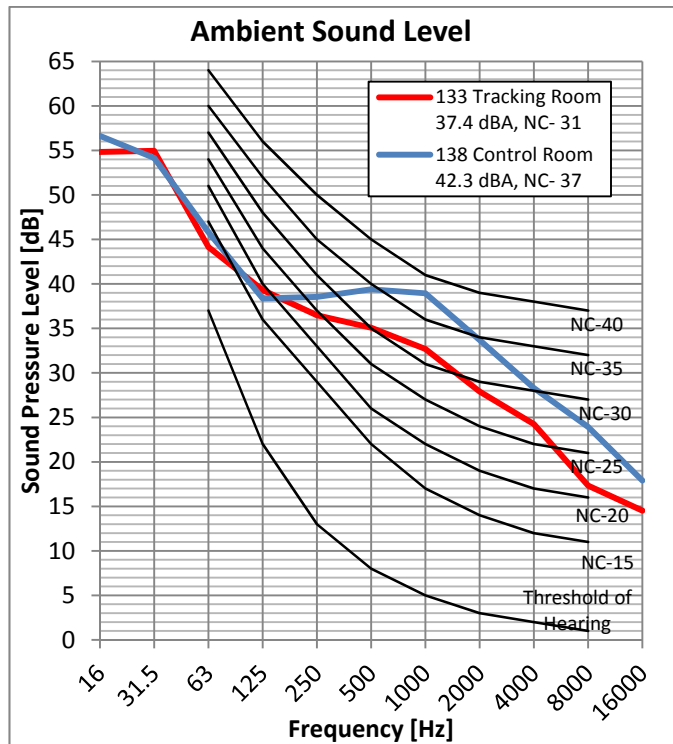
Figure 4.10 shows typical ambient sound pressure levels in the Tracking and Control Rooms. The ambient sound levels in the Tracking Room were measured at NC-31, 37.4dBA, dominated by fans in an analog-digital audio converter located near the performance area; in the Control Room levels were measured at NC-37, 42.3dBA, dominated by the five fans located on the rear of the mixing console. These levels are significantly above recommended levels, but it is important to note that HVAC system related noise is not noticeable in either room.

Figure 4.10- Ambient Sound Level Measurements

Ambient sound levels in the Tracking and Control Rooms were significantly higher than recommended for this type of facility, due primarily to cooling fans associated with the audio equipment. Great expense was taken, during the HVAC system design and construction, to provide extremely quiet conditions in the Studio area, and these efforts were successful in that HVAC noise is not noticeable in the sound-critical areas; however these efforts were somewhat in vain considering the noisy equipment that is installed inside the sound-critical areas. Equipment noise in the Tracking Room is dealt with by using close-mic techniques, portable sound barriers, etc.

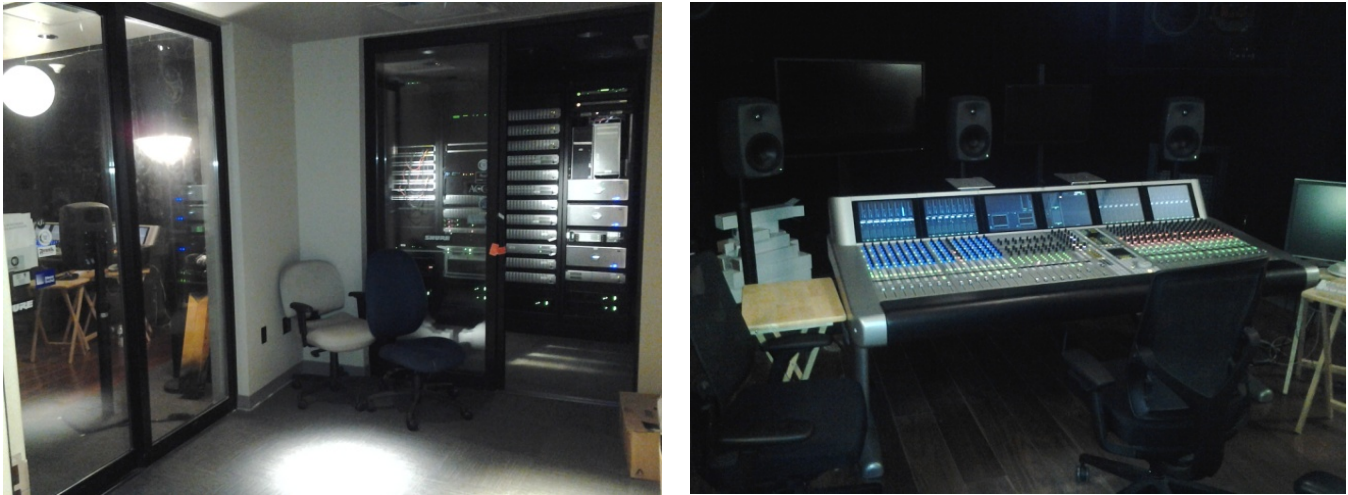
Figure 5.2- Interior views of the Audio Control Suite – Vestibule, with Control & Machine Rooms visible (left), console and near-field monitors (right)

The Audio Control Suite is located on the Floor level in the Back-of House area down a corridor approximately 40 feet from a sound rated loading door to the Theater. The Control Room is separated from the Corridor by a Vestibule with sound-rated doors; interior views of this area are shown in Figure 5.2.

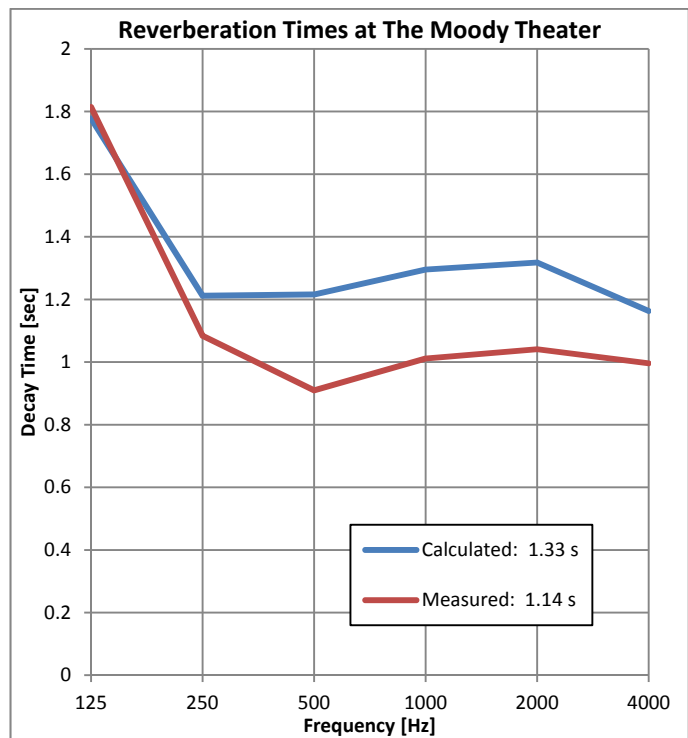
At the time of our visit, portable seating (folding metal chairs with thin pads at the seat and back) was being set up for an upcoming event, and the stage curtain was retracted. Reverberation decay time was measured at 1.14 seconds, and calculated at 1.33 seconds, broadband. Figure 5.3 shows that the decay times at the lower end of the audio frequency range are significantly longer than middle and high frequency times, which are otherwise generally equal around 1.0 second.

Figure 5.3- Reverberation decay time in the Theater

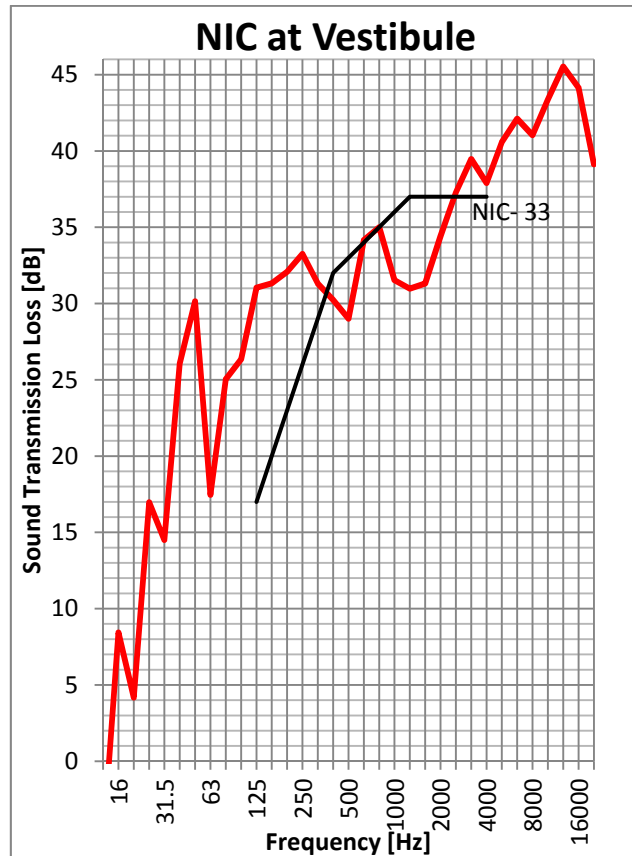
Figure 5.4- Results of sound isolation testing between Theater and Vestibule.

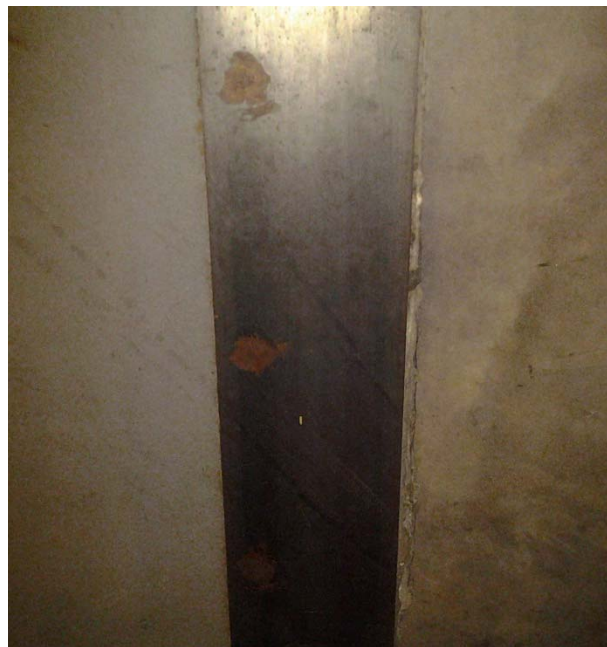
An isolated 'floating' floor is installed at the stage area of the Theater, extending part-way into the audience area on the Floor level. This is presumably designed to discourage vibration transfer from the stage to the building structure. After the facility was occupied, the gap between the isolated and fixed slabs was found to interfere with the portable bleachers, and the gap has since been bridged with sheet metal (see Figure 5.5). The details of how this was accomplished were not immediately available, but it is possible that the isolated floor has been rendered ineffective by bridging it to the fixed slab.

Figure 5.5- Junction of isolated and fixed slabs bridged by sheet metal.

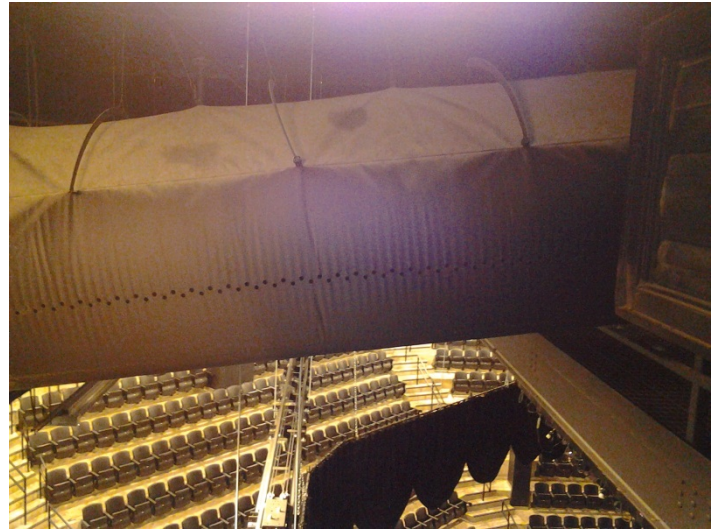
The HVAC needs of the Theater are served by several air handler units through perforated fabric ductwork over the main floor area, shown in Figure 5.7, and through traditional sheet metal ductwork at the upper level seating areas.

Figure 5.7- Fabric ductwork serving main seating area

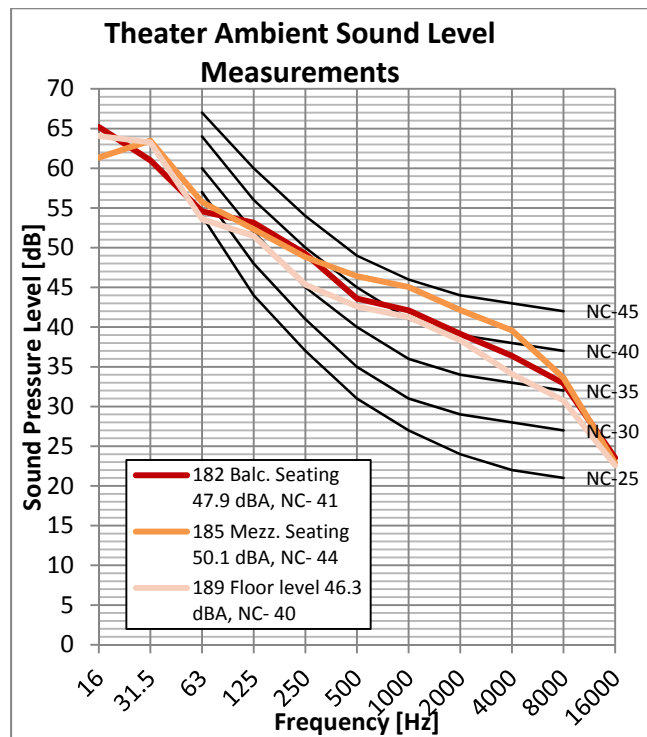
Ambient sound levels throughout the Theater hovered generally around NC-40, as shown in Figure 5.8, significantly higher than the maximum recommended NC-30 for this type of venue. The elevated ambient noise levels in the Theater can be

Figure 5.8- Ambient noise levels throughout the Theater

attributed to different sources based on the listener's location; the dominant noise source at the Floor level is the equipment in the bars, at the upper levels HVAC noise is more apparent. Ambient sound levels were found to vary considerably over the seating area, with some seats experiencing levels as loud as 50.1dBA, NC-44. High ambient noise levels have been problematic during particularly quiet performances.

Ambient sound levels in the Theater were somewhat higher than recommended for this type of facility, due primarily to noise generated by bar equipment at the Floor level, and to HVAC noise at the upper seating levels. Ambient sound levels were found to vary considerably over the seating area, but were generally higher than recommended for a music performance

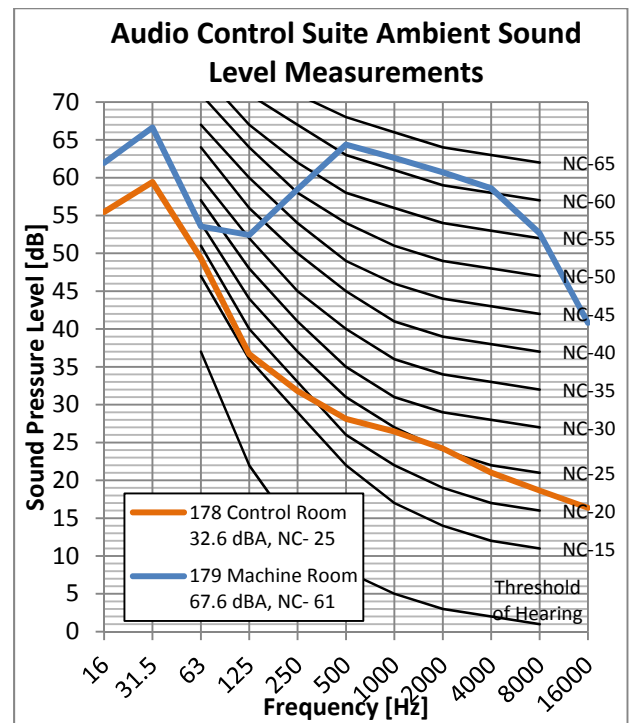
Figure 5.9- Ambient noise levels in the Audio Control Suite

Ambient sound levels in the Audio Control Suite are shown in Figure 5.9. Levels in the Control Room were found to be 32.6dBA, NC-25, within the recommended range for this type of room. Levels in the Machine Room were measured at 67.6dBA, NC-61.
